# Victoria Cross Integrated Station Development

**Client:** Sydney Metro  
**Project:** Victoria Cross Intergrated Station Development  
**Value:** AUD\$1.2 billion for station and over station development  
**Location:** North Sydney  
**Date:** 2022  
**Unit:** AR10 (WLL 10 tonnes)  
**Usage:** Controlling the orientation of structural formwork, reinforced steel and stillages whilst lowering down access shaft.

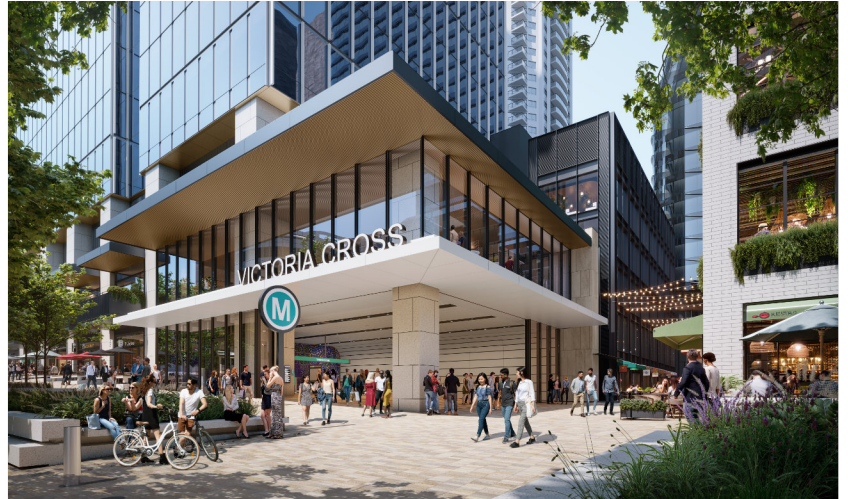
Underground station, 31 metres below ground level, located in the heart of the North Sydney business district.

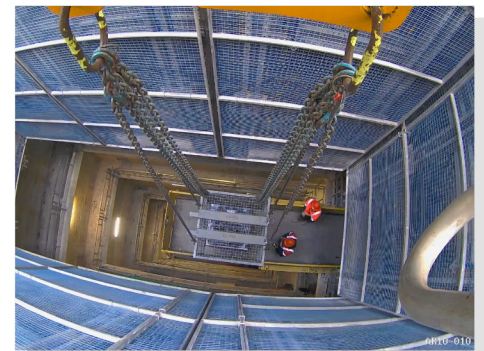
To control loads when lowering through the shaft without hitting the screens, a 60 metres tagline would have been required, which was not practical or safe. Roborigger allows control without a tagline. The lifting team was able to keep loads controlled during transit, mitigating risk to both personnel and structures.

During the Victoria Cross integrated station development, the bottom level of the site was 31 metres below ground level, with loading decks installed on the levels above. Materials being lifted in and out of the 7 metres by 2.5 metres shaft included structural formwork, reinforced steel, stillages as well as palletised items. The construction schedule was governed by the capability of the crane to support the underground operations through the single access shaft.

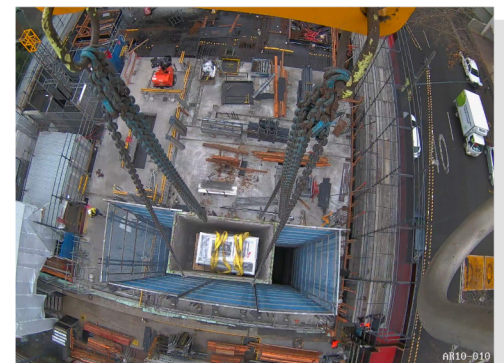
Lendlease adopted the Roborigger AR-10 for the project lifetime to guarantee that all loads were positioned and controlled securely in the air during the lift. Two remotes were used, one by the Roborigger operator (rigger or dogman) positioned at ground level and another in the lower basement.

The rigging team also utilised Roborigger for all general lifting activities due to the safety benefits of better load control when lifting around obstructions such as the slipform, formwork, scaffold, and hoists.
